LAKE PARAN DAM

VT00006

NORTH BENNINGTON, VERMONT

PHASE I INSPECTION REPORT
NATIONAL DAM INSPECTION PROGRAM

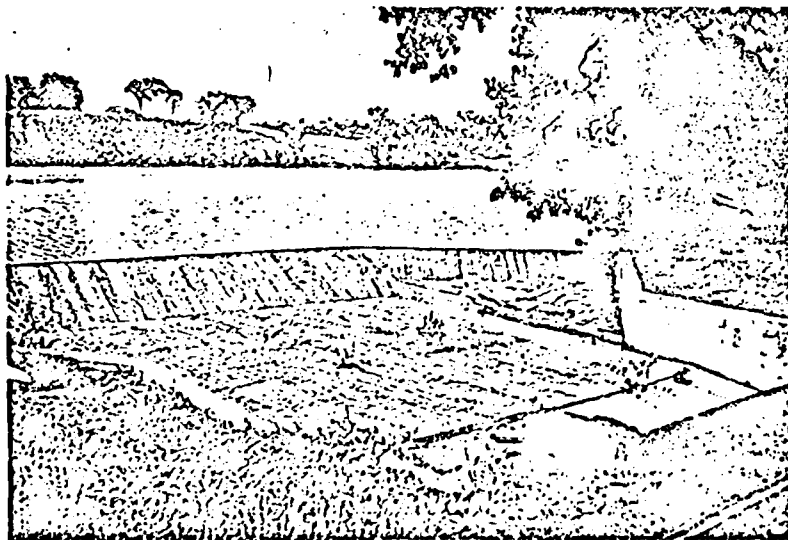
Fig. 1 Timber portion of chute spillway, Lake Paran dam

The new construction on the spillway section is practically complete. The spillway section of the dam is made up of timber planking over stone fill. The planking and timbers were old and rotting so that water was leaking thru it. The old timber and loose rocks have been removed and replaced with concrete. The overflow crest is 90 feet long and is built in a semi hexagon fashion. The upstream face is vertical, a crest width of 1 foot and a downstream slope of approx. 45° . This then leads to a chute some 4 feet lower than the crest. The chute is some 40 feet wide leading to a bridge under the railroad. The railroad fill makes up the rest of the dam. It is approx. 4 feet higher than the crest of the spillway.
